Woodlot Licence W1832
Forest Development Plan #1
Term: January 1, 2000 to December 31, 2004

Licensees: Tom Bradley, Bernie Clover, Breakaway Enterprises Ltd.

Arrow Forest District
Nelson Forest Region

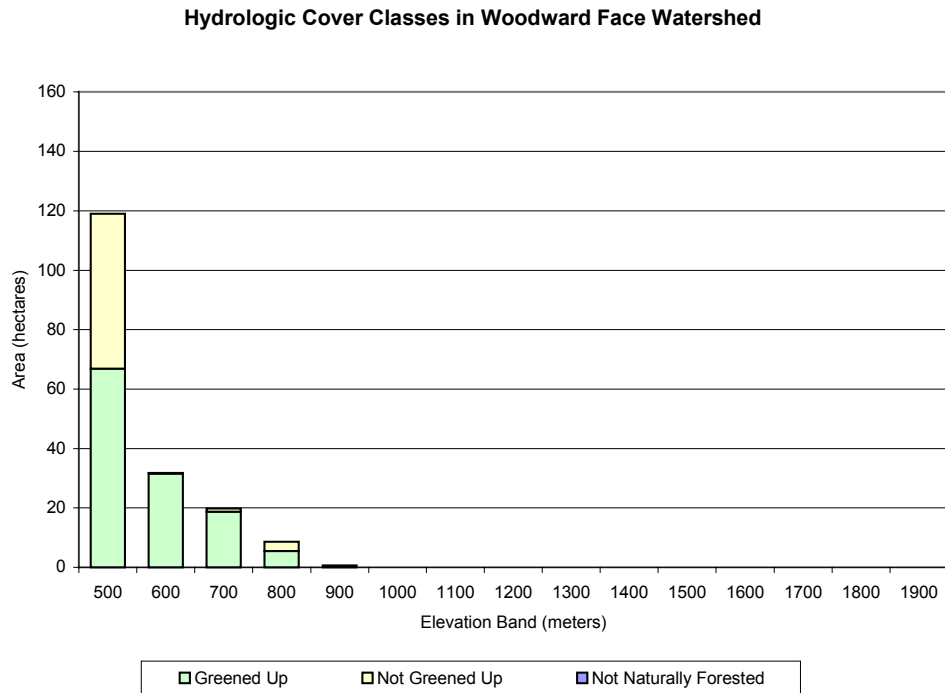
Figure 5: Hydrologic Cover Classes in Woodward Face sub-unit.

Figure 5 shows the concentration of clearing for settlement and road building in the lower portion of the watershed.

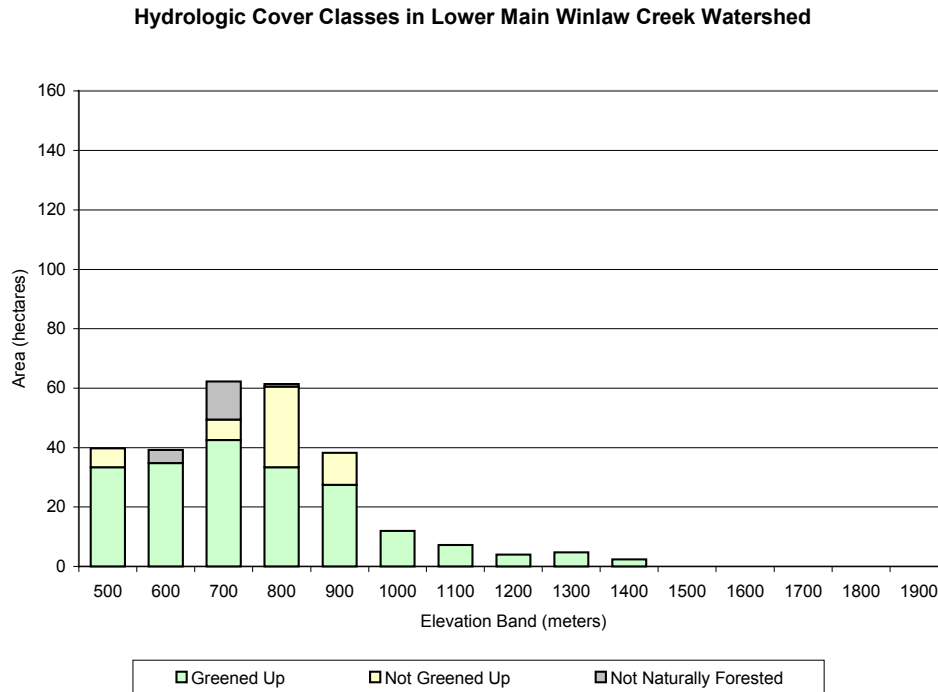
Figure 8: Hydrologic Cover Classes in Winlaw Lower Main sub-unit.

Figure 8 shows the relatively even distribution of the watershed across elevational bands, as well as the extensive non-forested slopes between 600 and 800 meters elevation. The large “not greened up” area between 800 and 100 meters elevation is the deer range area in W1832. This area is described in the forest cover data as an old forest fire which is currently not sufficiently restocked. This does not appear to be a completely accurate description – the area may never have been “fully stocked” with coniferous trees due to growing site limitations, and may currently be fully occupied by deciduous shrub and scattered coniferous tree vegetation at close to the site carrying capacity. We regard this

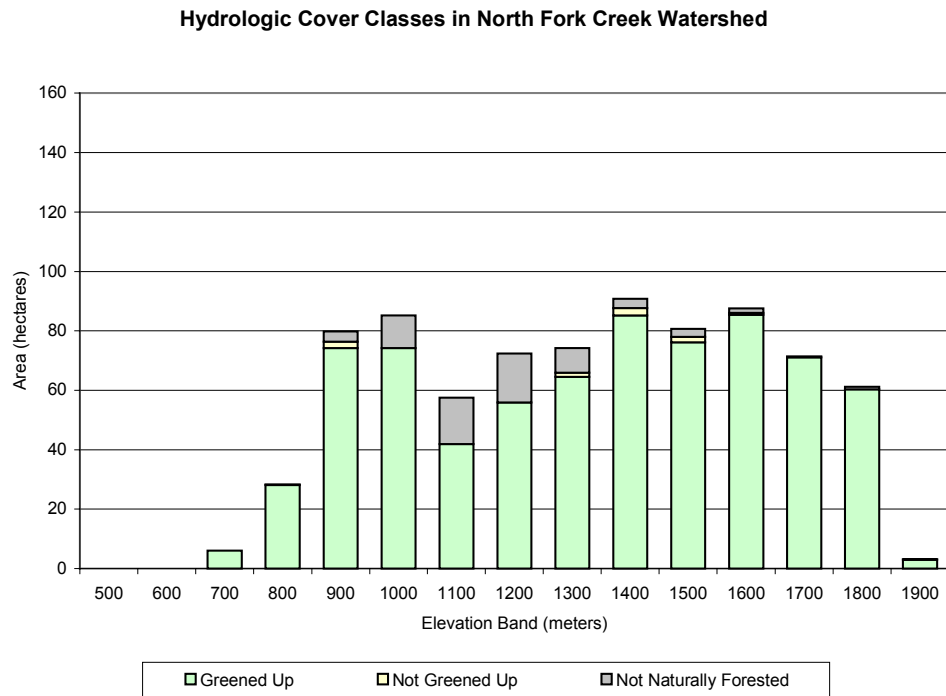
Figure 10: Hydrologic Cover Classes in North Fork Creek sub-unit.

Figure 10 shows the relatively even area distribution across elevational bands in the North Fork sub-unit. The broad elevational range of non forested terrain, mainly south facing steep slopes, is also illustrated, as is the dearth of disturbed areas.

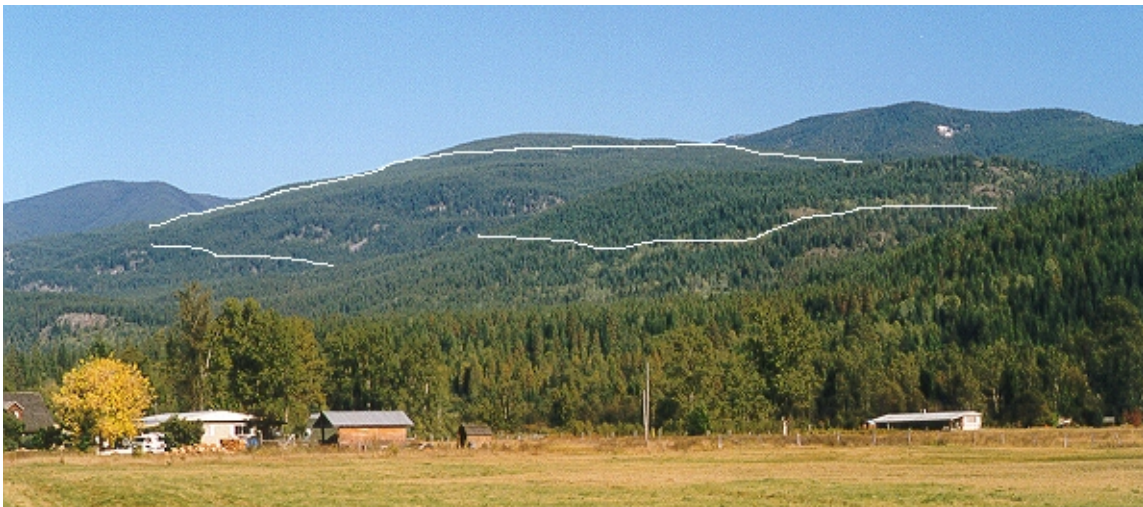
Figure 16: W1832 from near the bottom of Kazakoff Road, south of Winlaw.

The approximate extent of the woodlot is outlined in white. The low ridge on the right edge of the woodlot screens Blocks 1 and 2 from view. Silica Mine Road crosses the dry, open slope on the lower right edge of the Woodlot, but is well screened from view by established vegetation which will be retained.
